THE DEVELOPMENT OF THE OLD HOUSE ON LUNDY

MYRTLE TERNSTROM
6 Queensholme, Cheltenham GL52 2QE

An account of changes to the Old House from the construction, through its uses as a divided residence, the farmhouse, and the hotel, to the present Old House North, Old House South, and the Tavern block. The description is drawn from the evidence found in maps, written references, a drawing, plans and photographs.

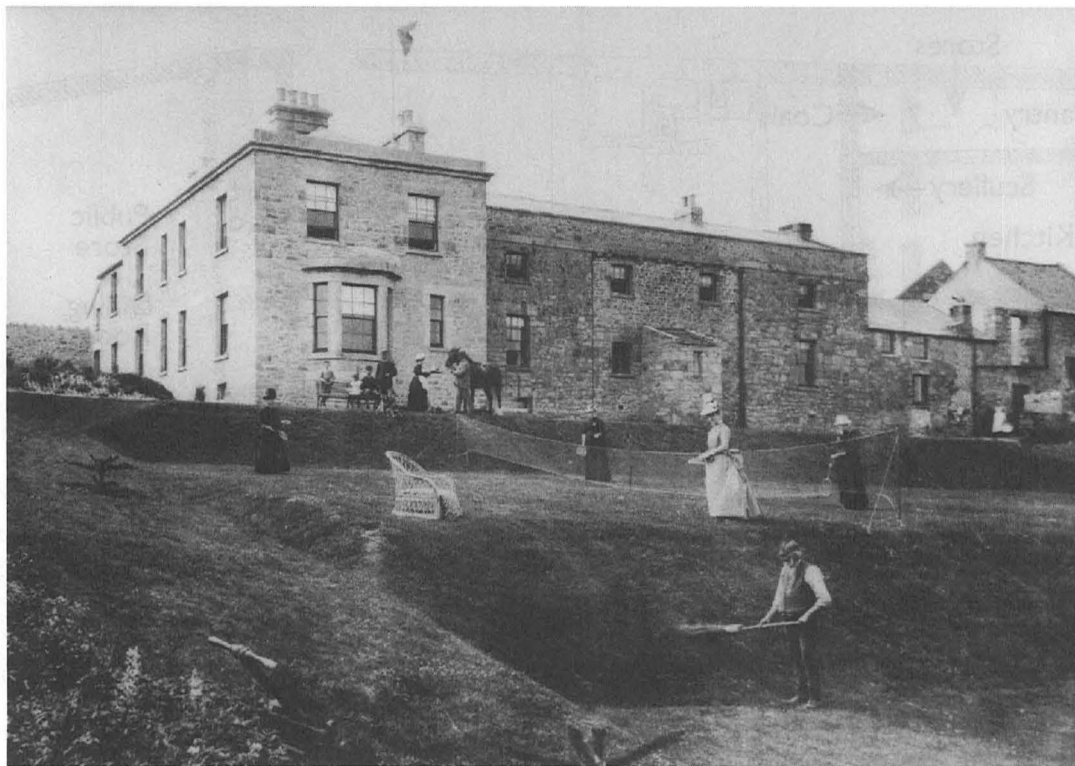
Figure 3. The Manor House and Farmhouse in 1886. (photo from the Heaven collection)

From the date of Mr Wright's tenancy (1885) the buildings were known separately as the Manor House and the Farmhouse, denoting the fact that he was a gentleman in residence. In the photograph of 1886 (Figure 3) the east wall of the north addition to the main building has two upper windows and one lower window (of a different style from those of the main building) and the chimney has been rebuilt. The masonry below the lower window shows a filled-in door, indicating that the addition was originally a separate dwelling. The symmetry of the original building, and the line of the masonry between it and the north part, confirm this as having been an addition. The plan of 1885 (Figure 4) shows this addition as "scullery and wash house" with through connection to the main building, and an entrance at the west.

The photograph (Figure 3) also shows that a further addition was made between this and the storekeeper's cottage at the north end of the building, of which only part of the east façade, with a door, and a first floor wall remained standing. In both the 1885 (Figure 4) and 1918 plans (North Devon Record Office, 1918) the area is shown as an enclosed courtyard. The long narrow upper window or doorway suggests the use of a hoist, but alternatively the roofline contiguous with the 1863-64 storekeeper's cottage to the north, may indicate an uncompleted addition. Any remaining evidences were lost during alterations 1926-27.
